TECHNICAL INSPECTION REPORT

6 OPERATION CROSSROADS.
U.S.S. CRITTENDEN (APA 77)

TEST ABLE.

VOLUME 2 [U].

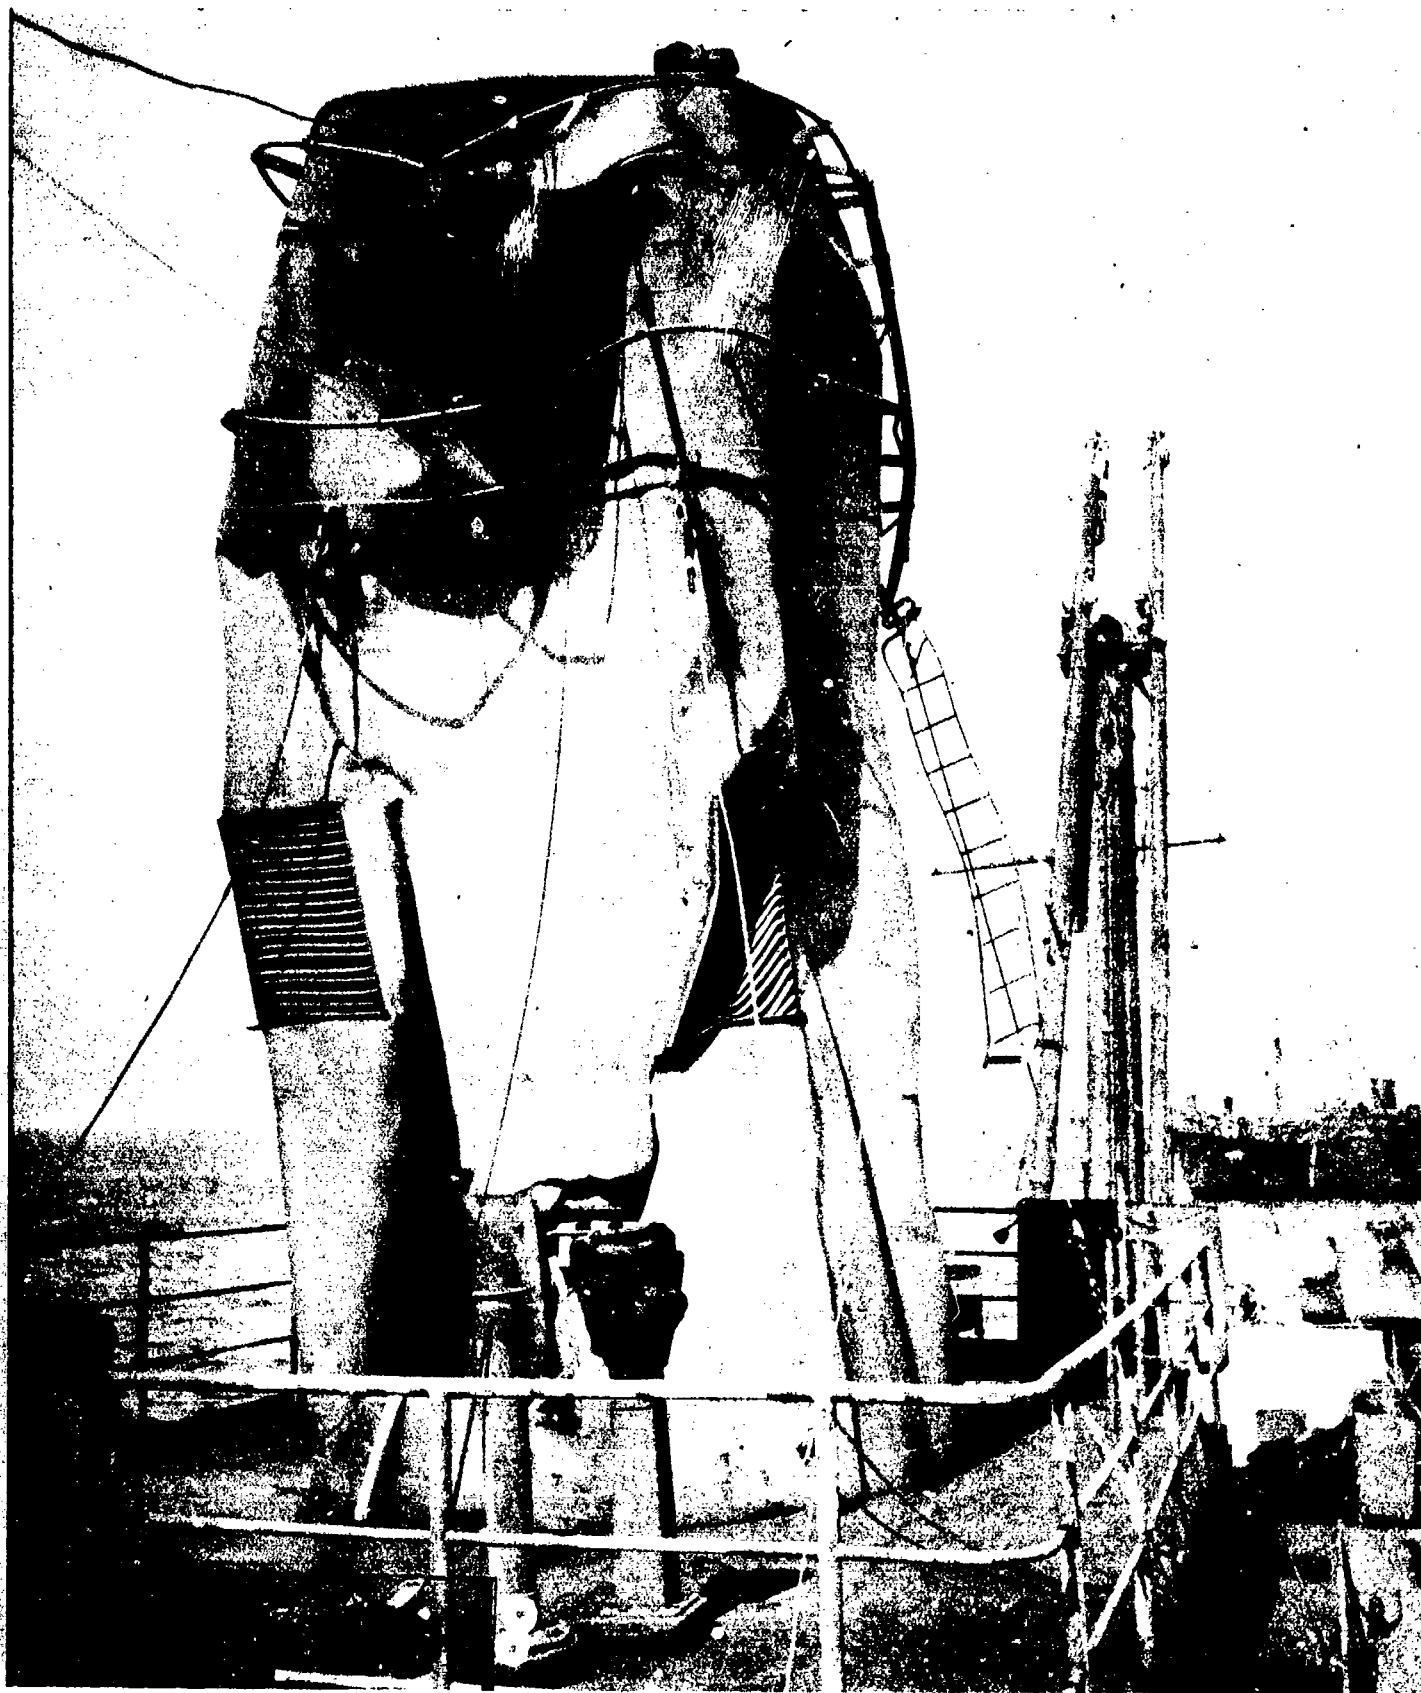
AA-CR-80-1904-8. Looking aft on signal bridge level showing damage to after stack and sky lookout tub.

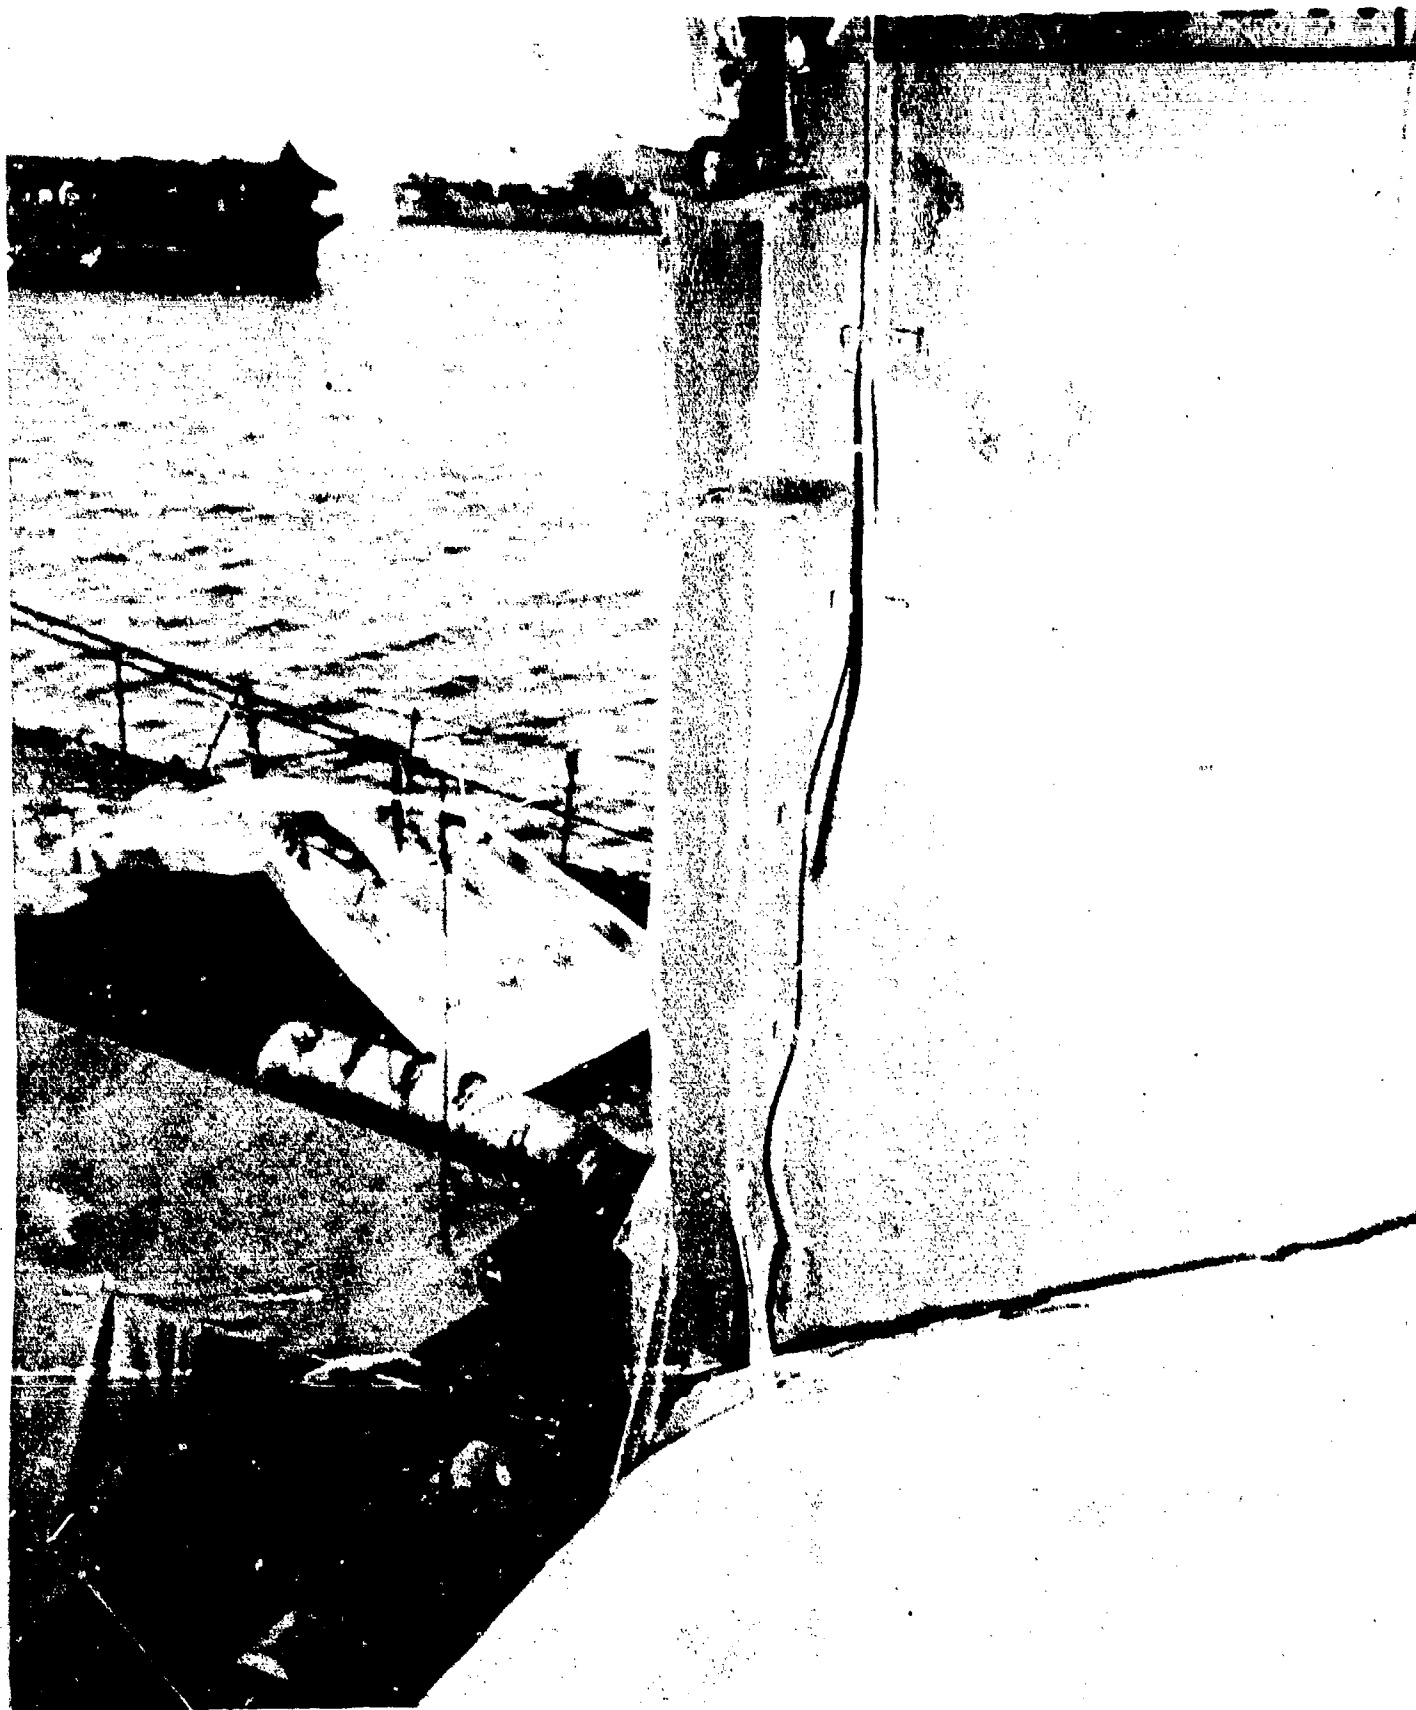
AA-CR-59-2058-6. Looking forward and to starboard from port wing of navigating bridge showing damage to bulwark. Refer to 1960-4.

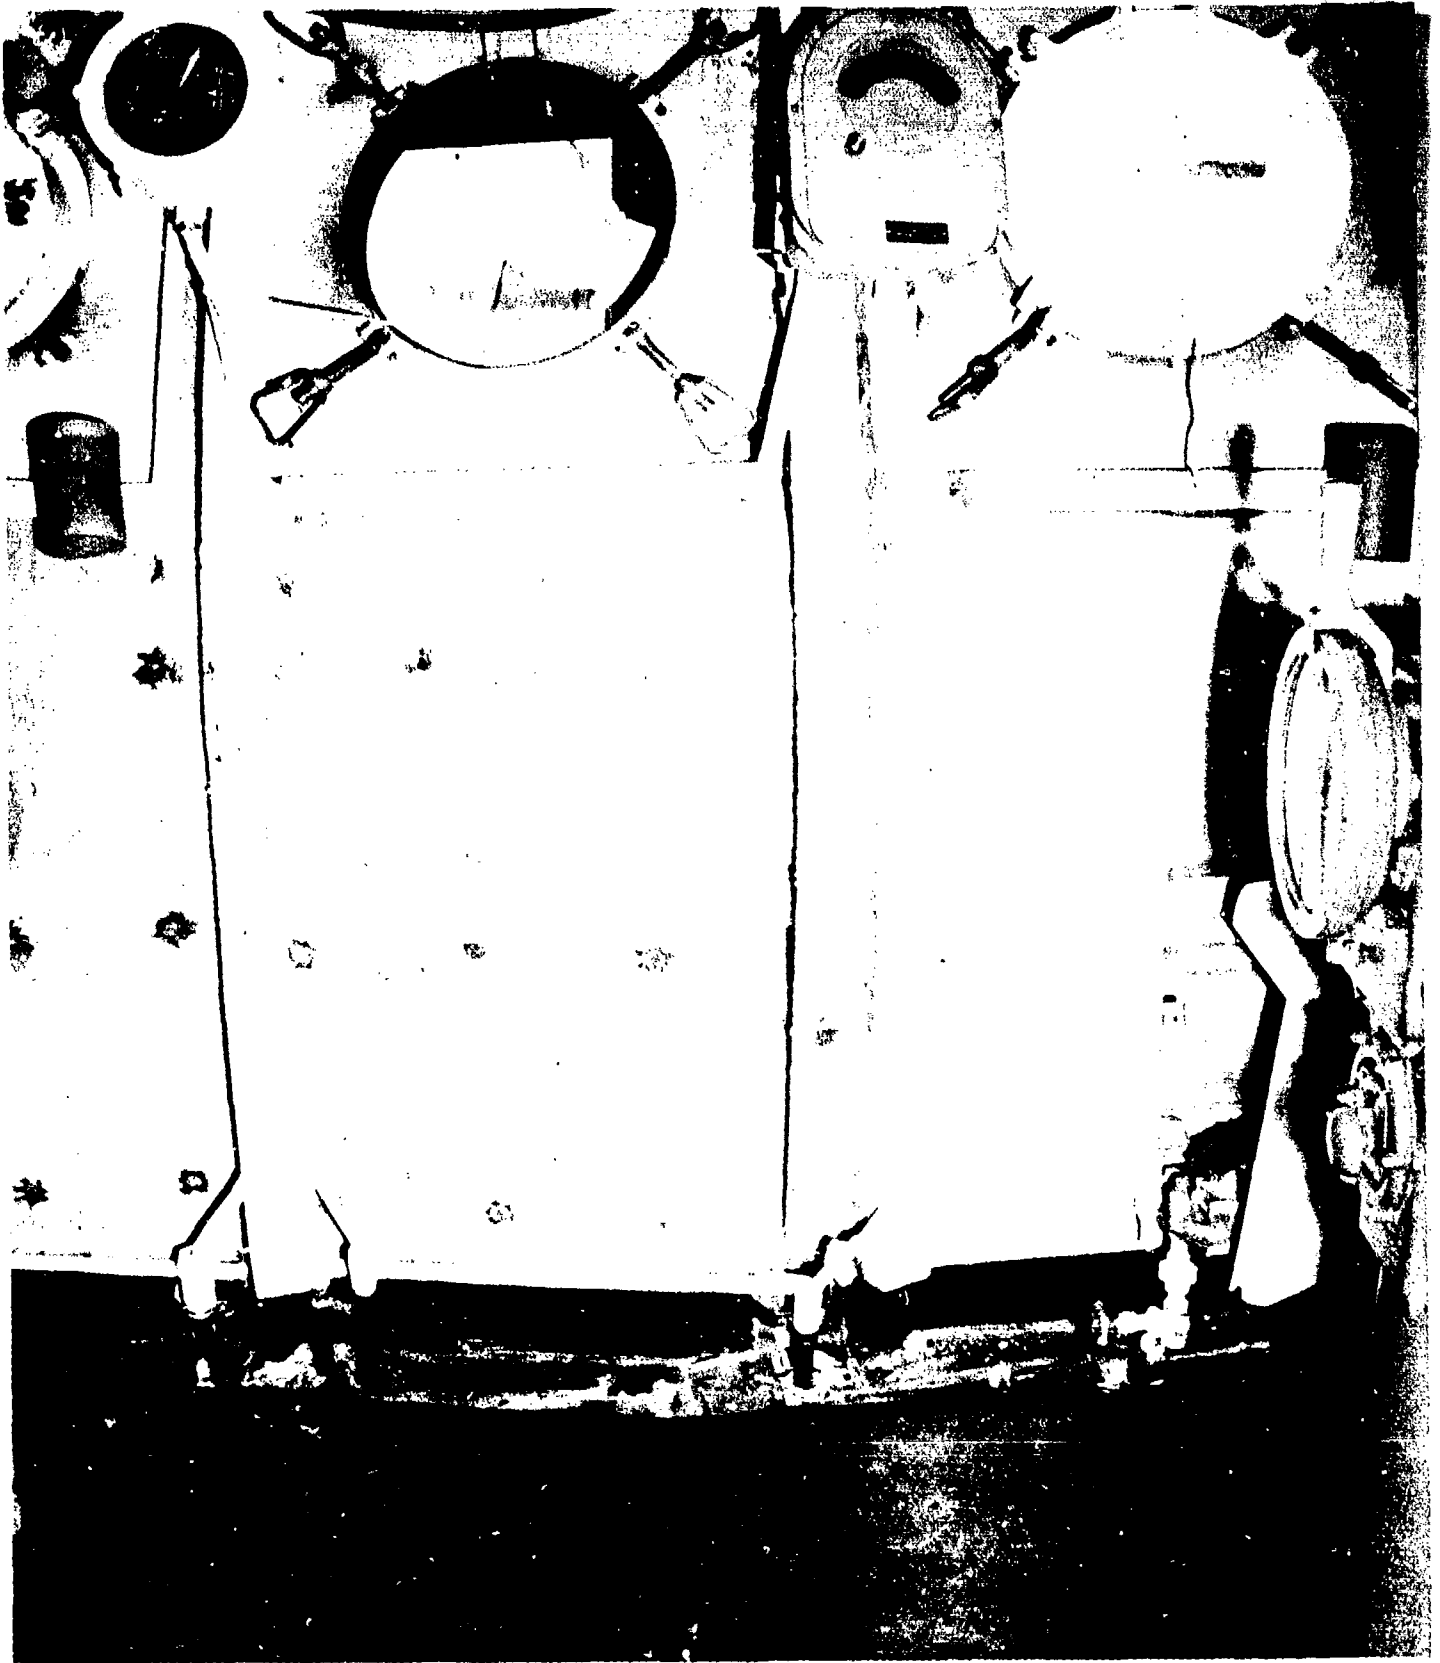
AA-CR-59-2058-4. Looking forward in pilot house showing damage to forward bulkhead and only slight damage to instruments.

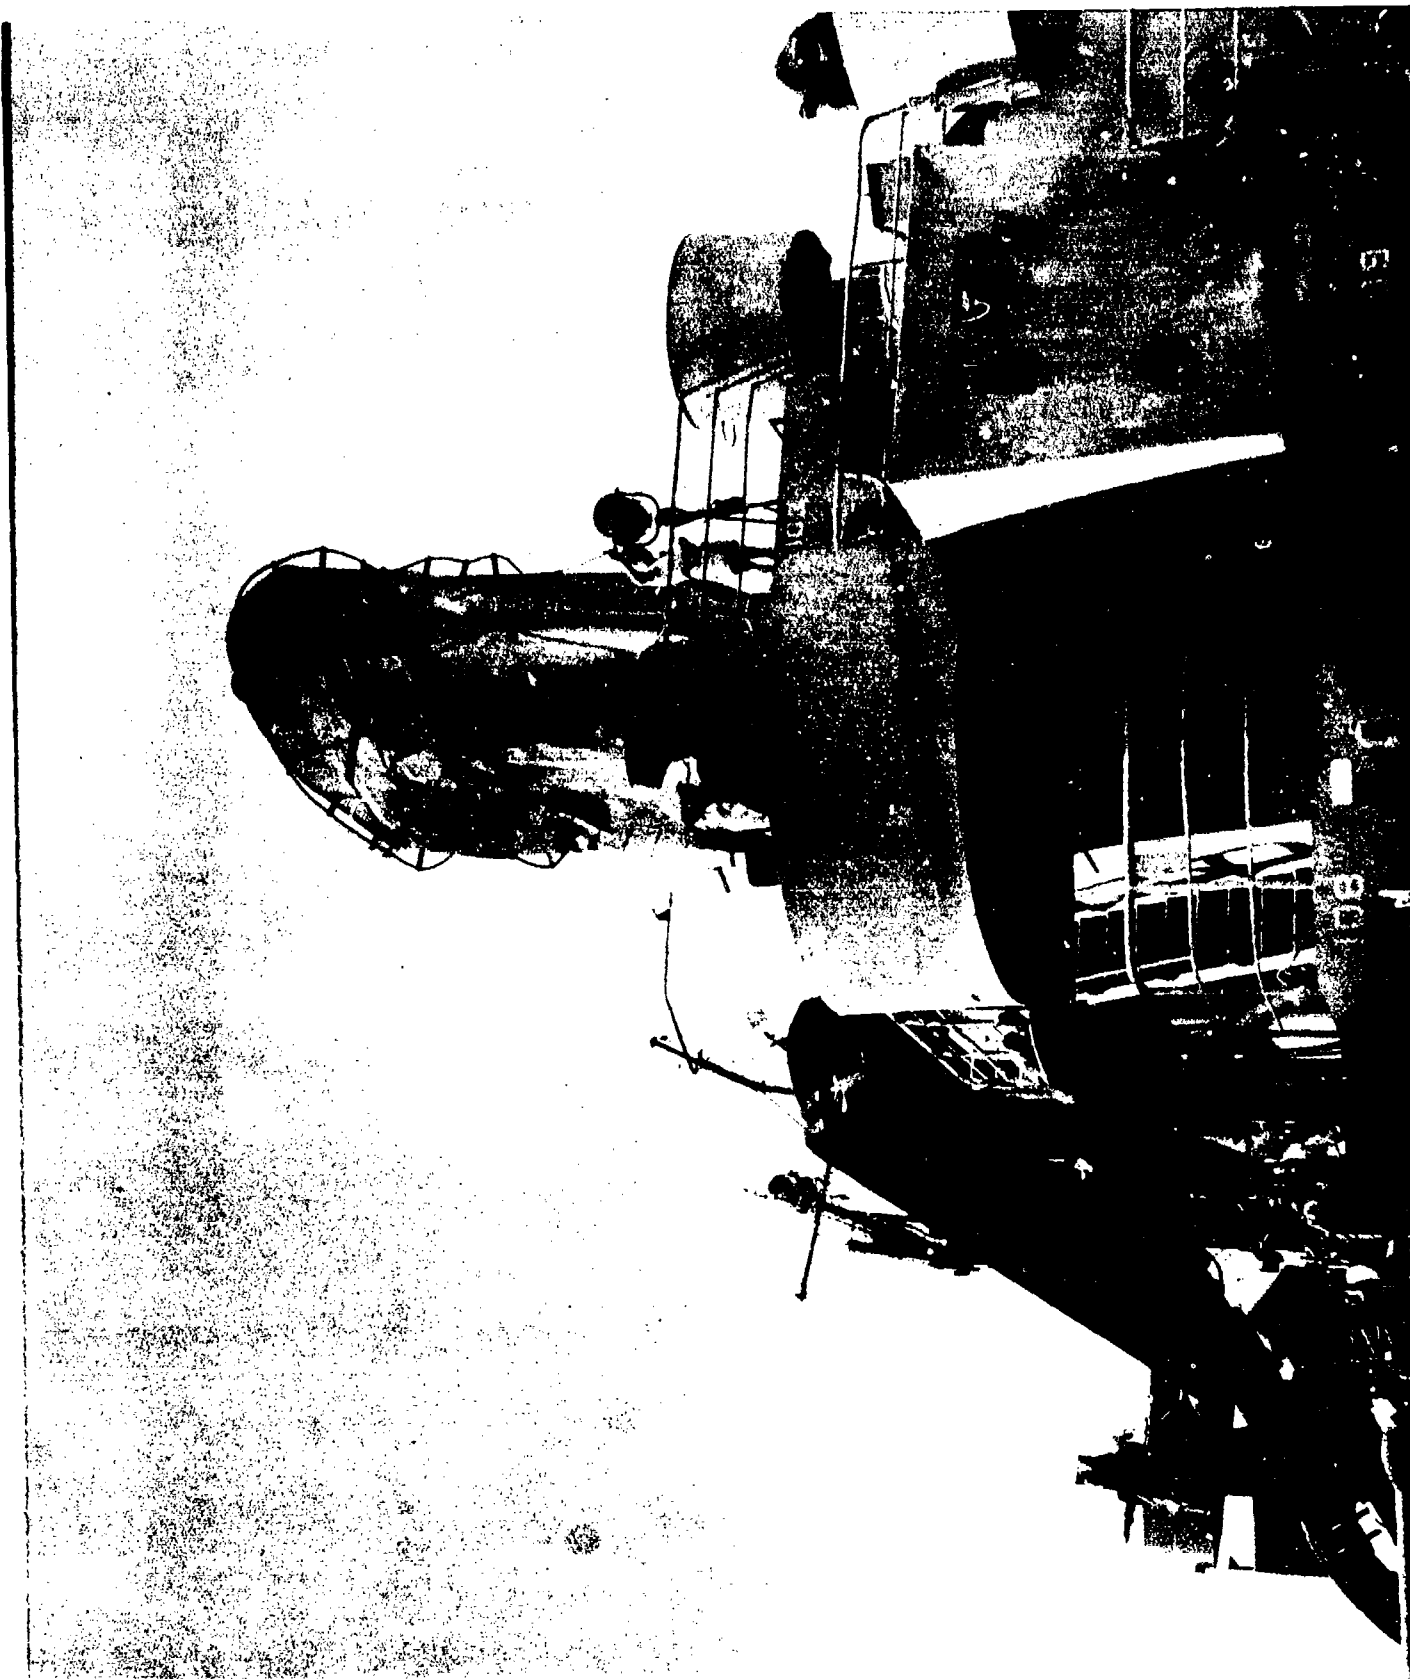
AA-CR-80-1906-11. Looking forward and to starboard from upper deck showing damage to port davits, moving picture projection house, and after stack.

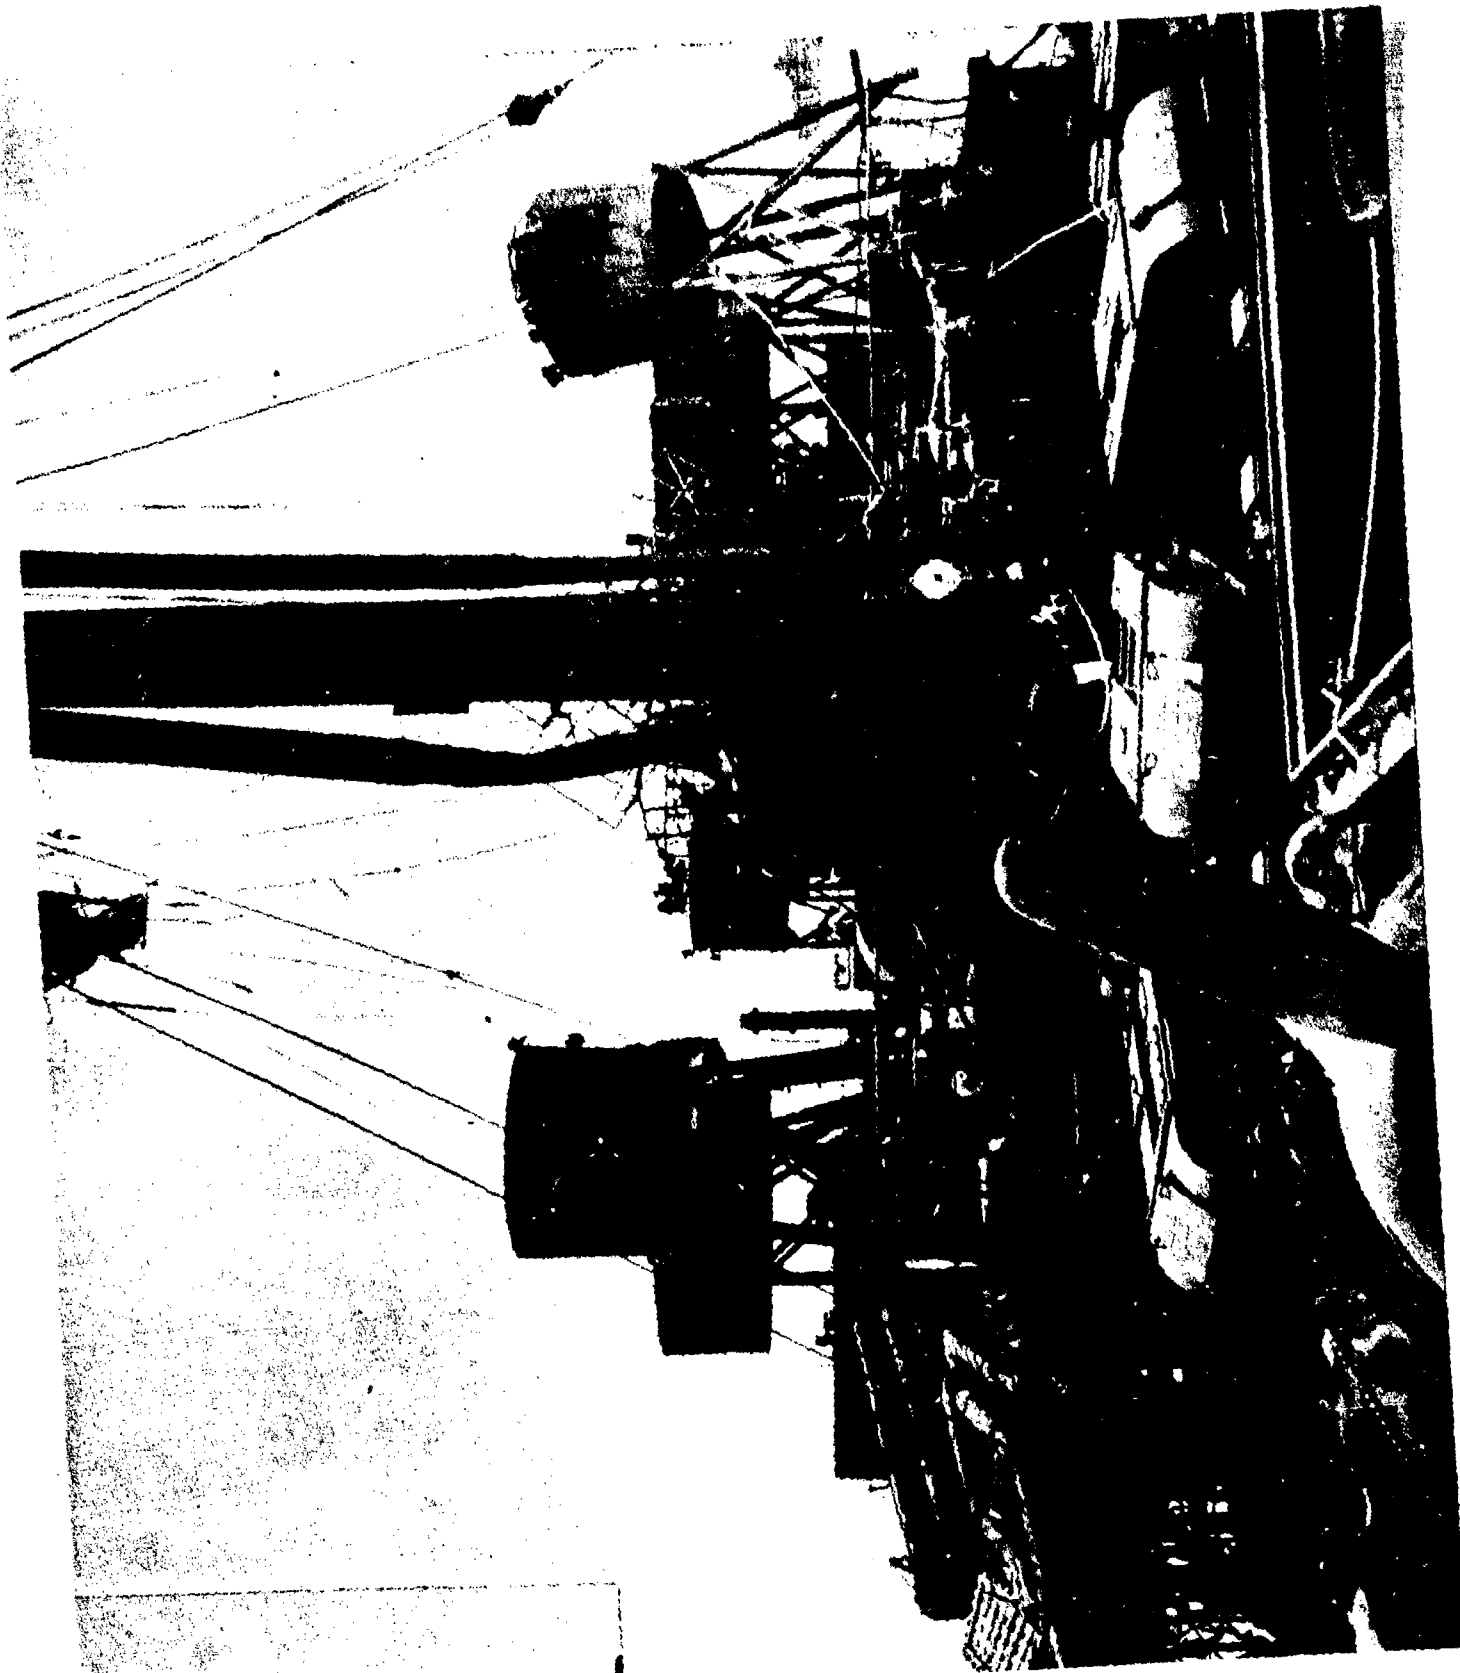
AA-CR-98-1961-10. View looking aft and to port showing bent boom on mainmast and damage on top of after deck house.

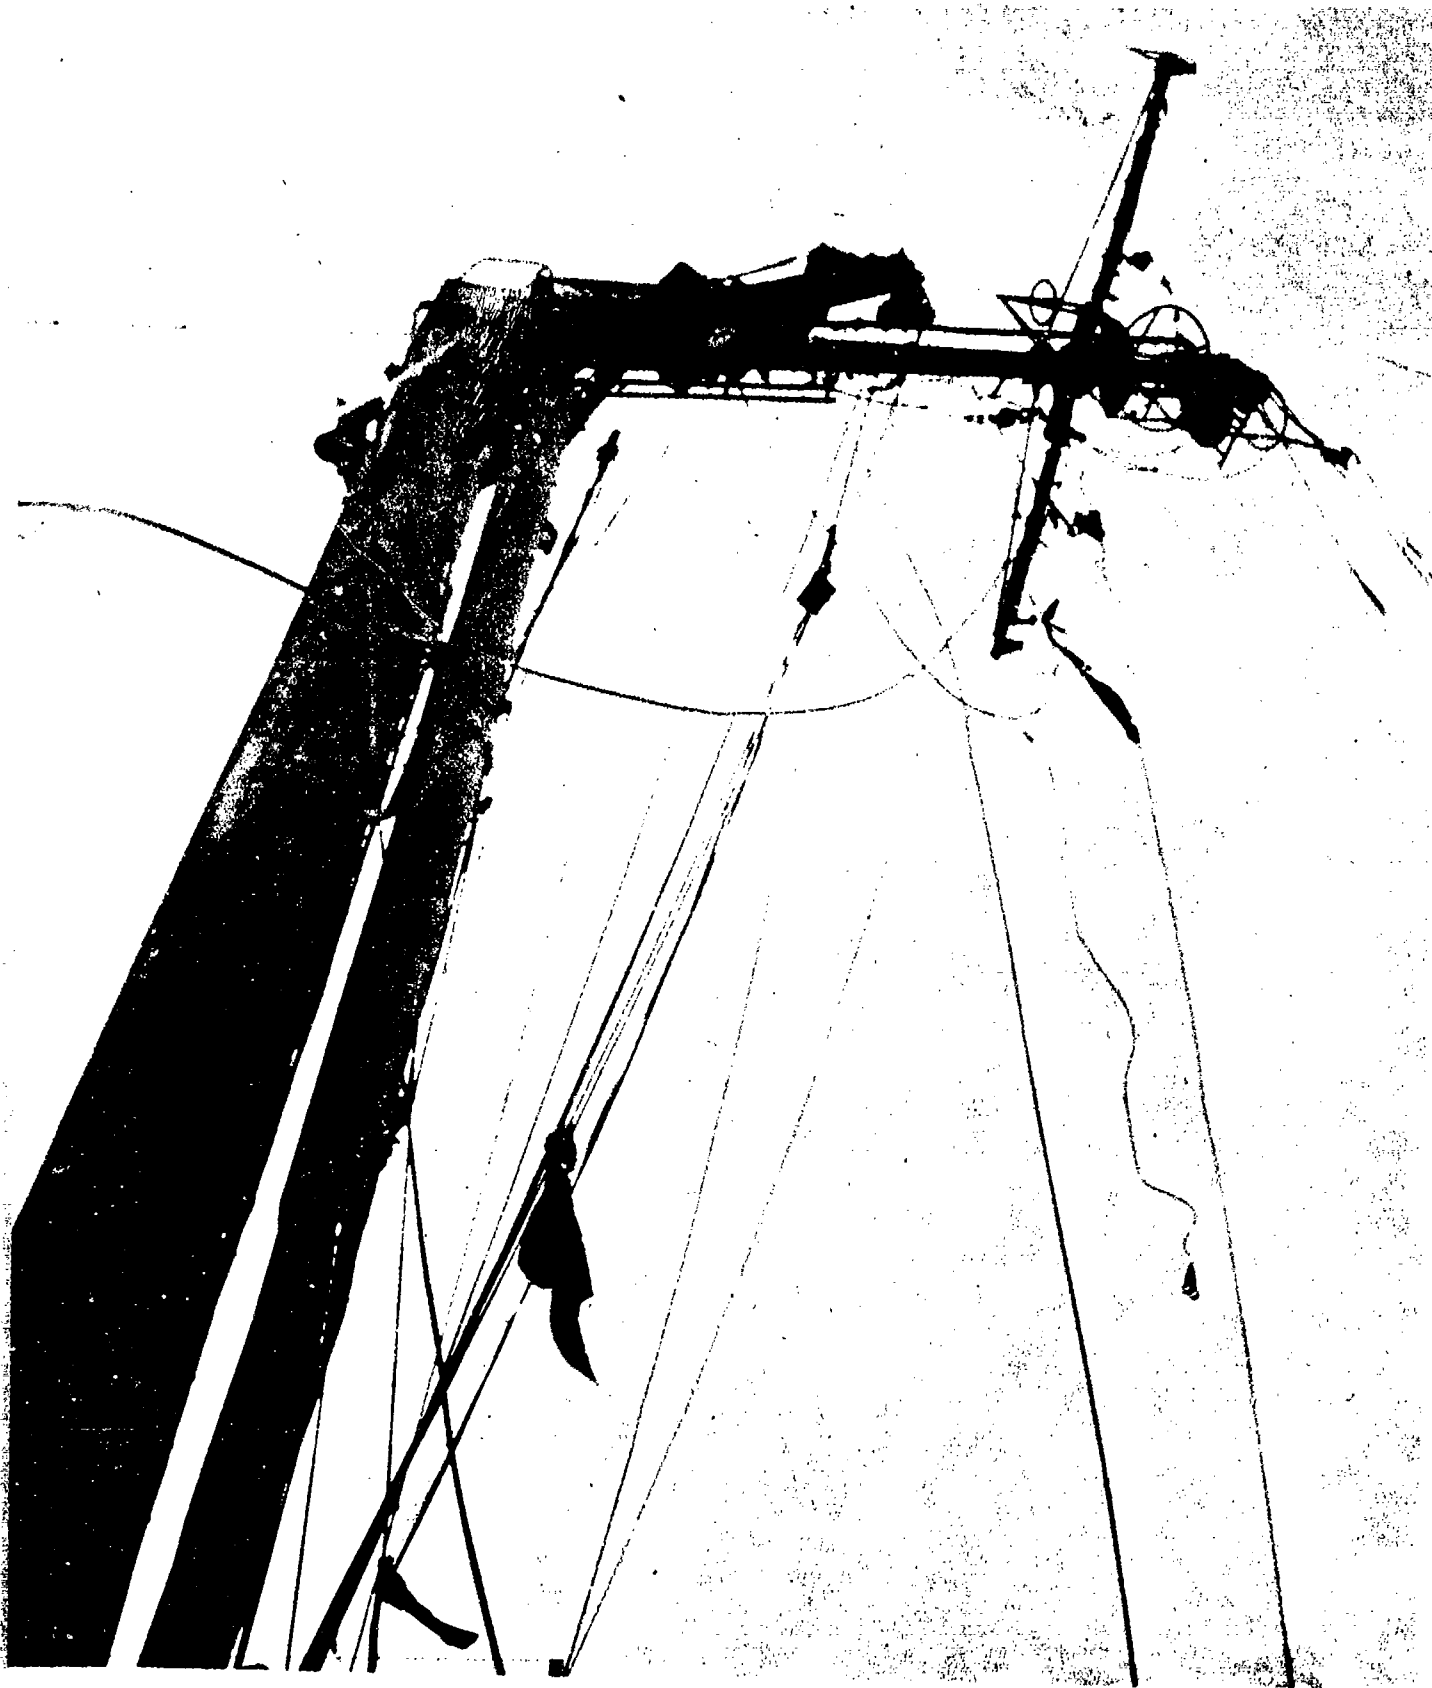
AA-CR-82-1921-10. Looking up and to starboard showing damage at top of foremast and to cargo booms.

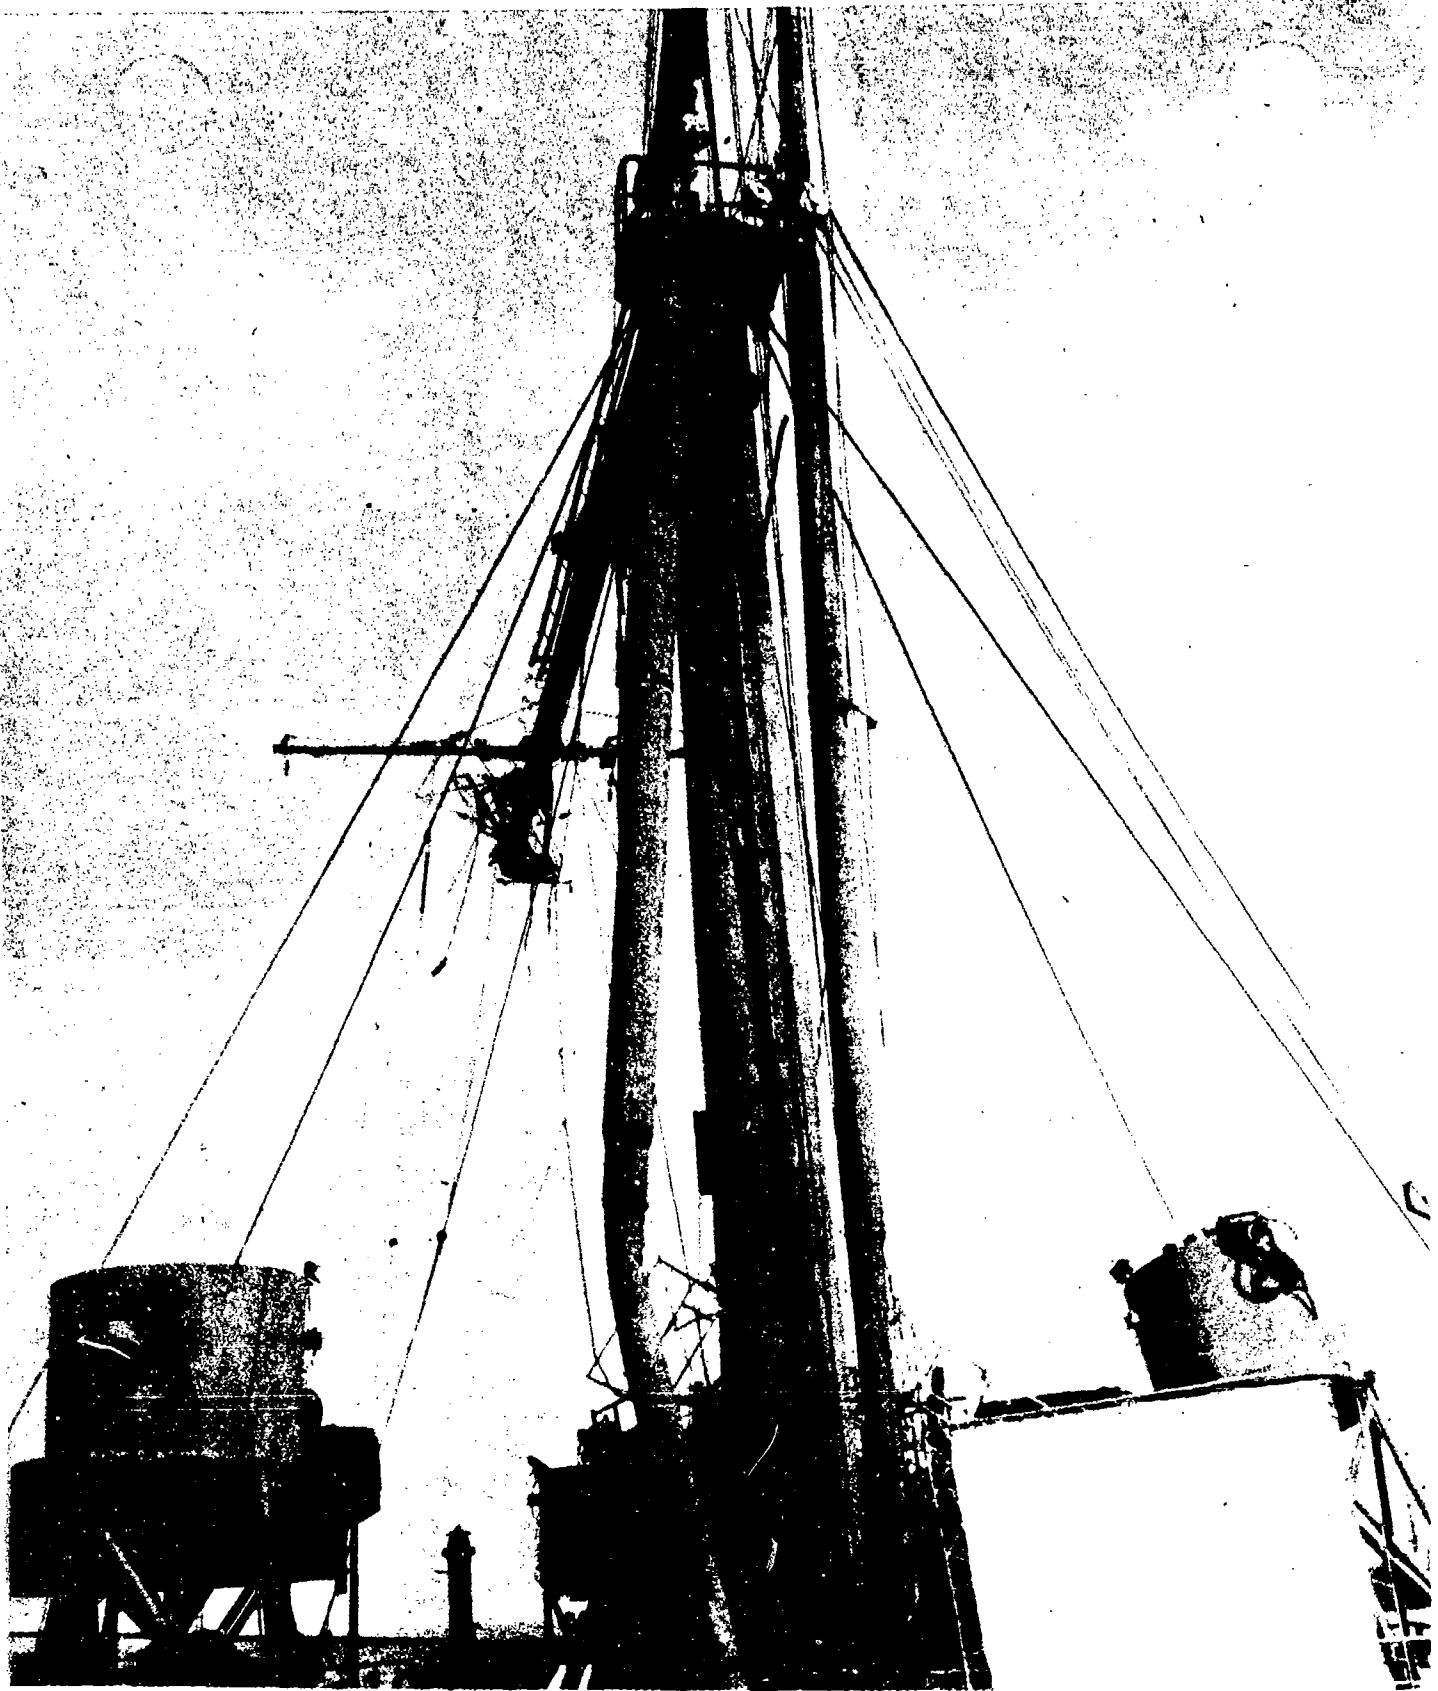
AA-CR-80-1905-11. Looking aft on upper deck showing damage on mainmast and top of after deck house.

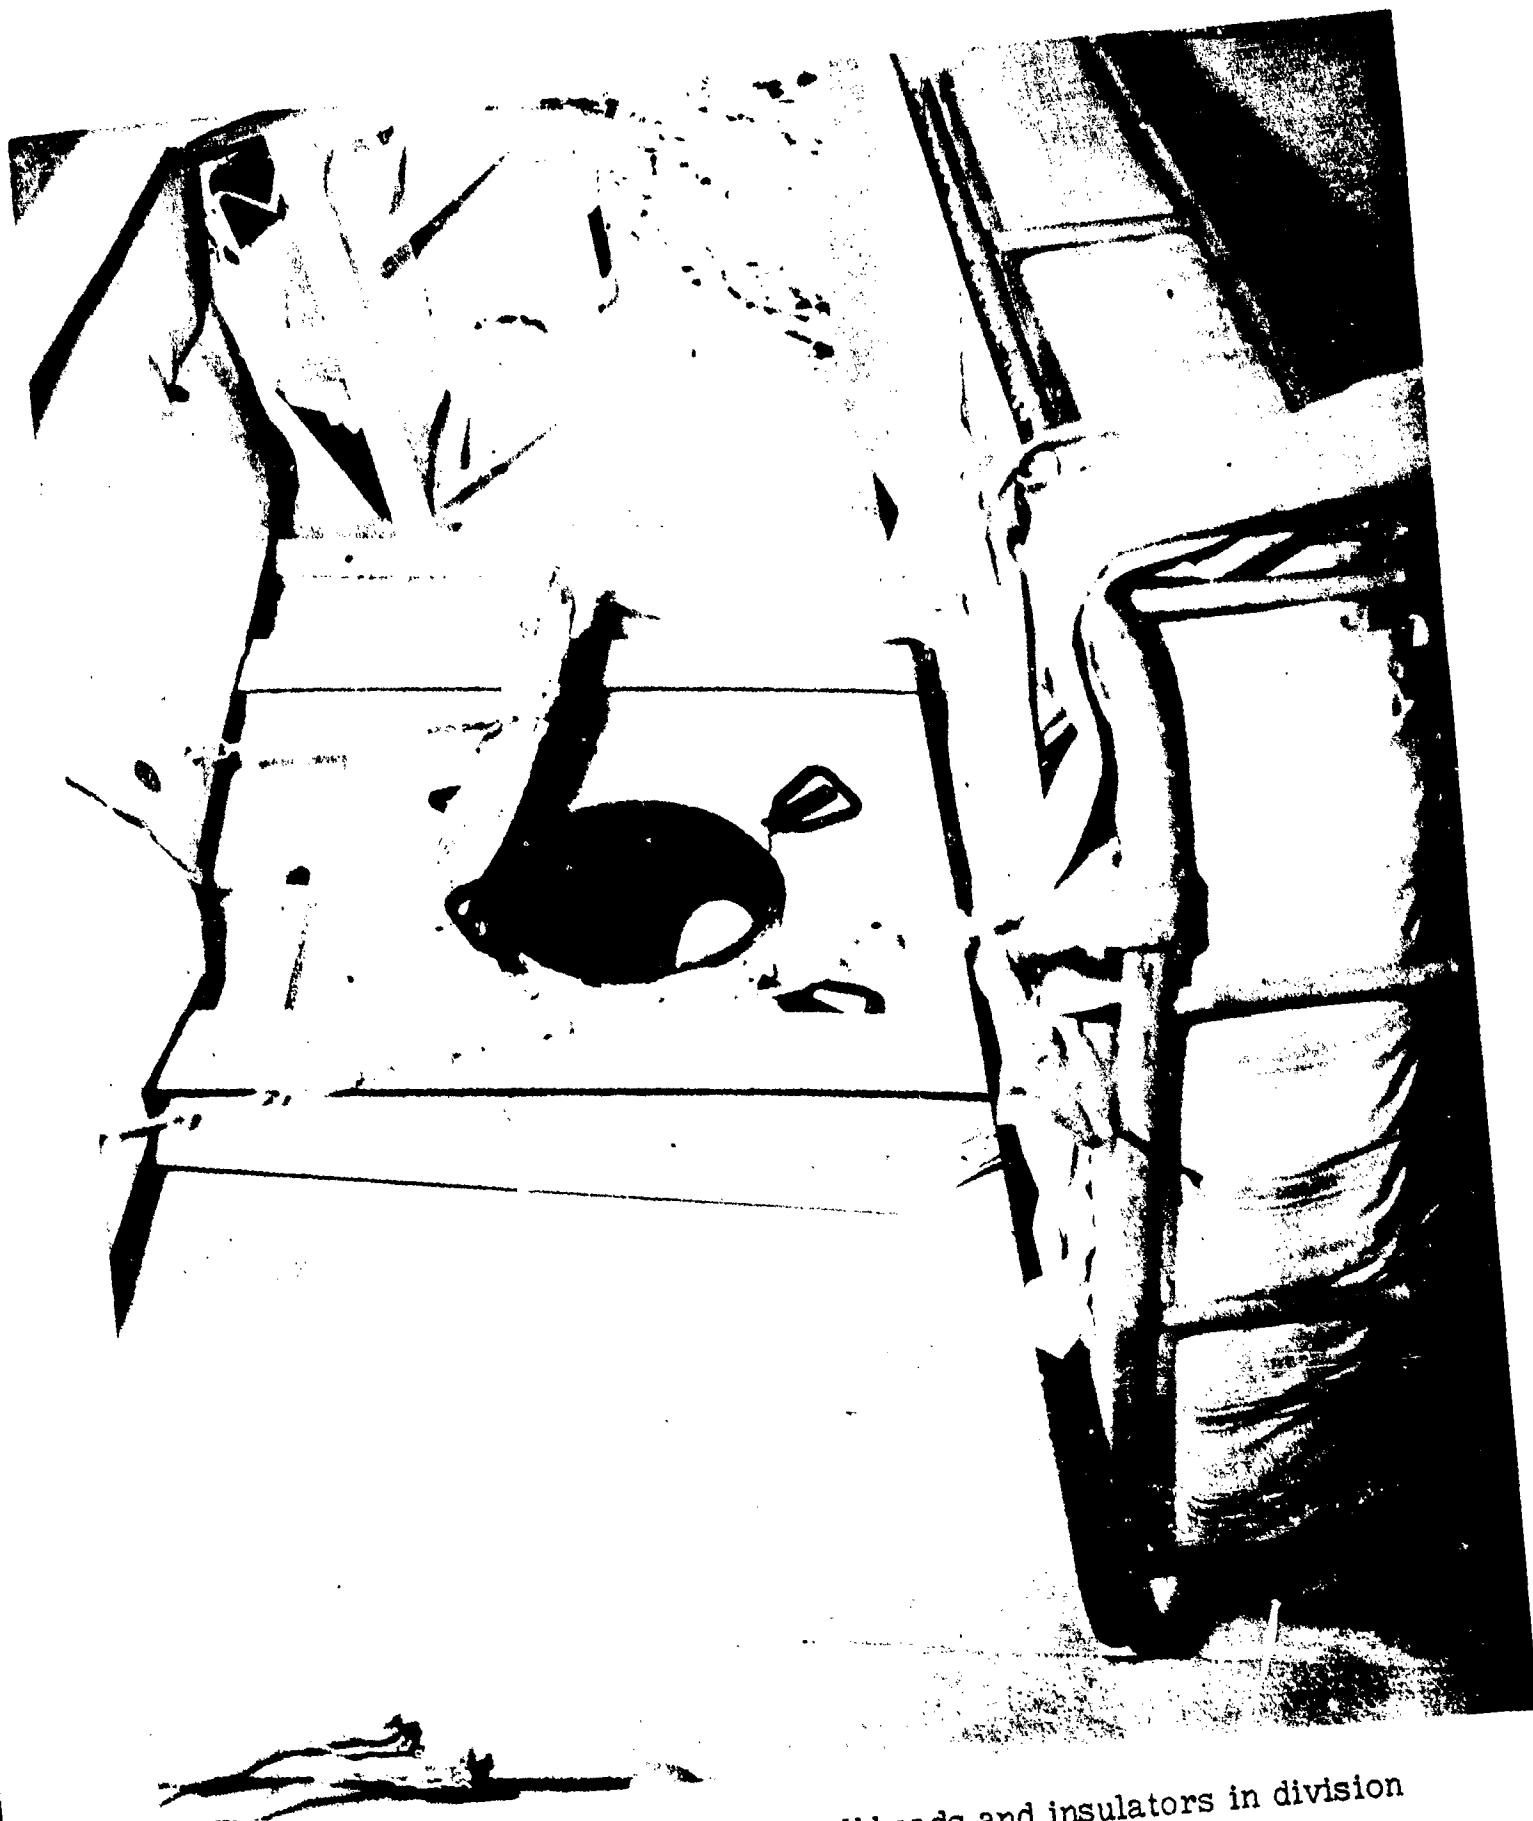
AA-CR-80-1906-6. Damage to bulkheads and insulators in division commanders stateroom, superstructure deck.

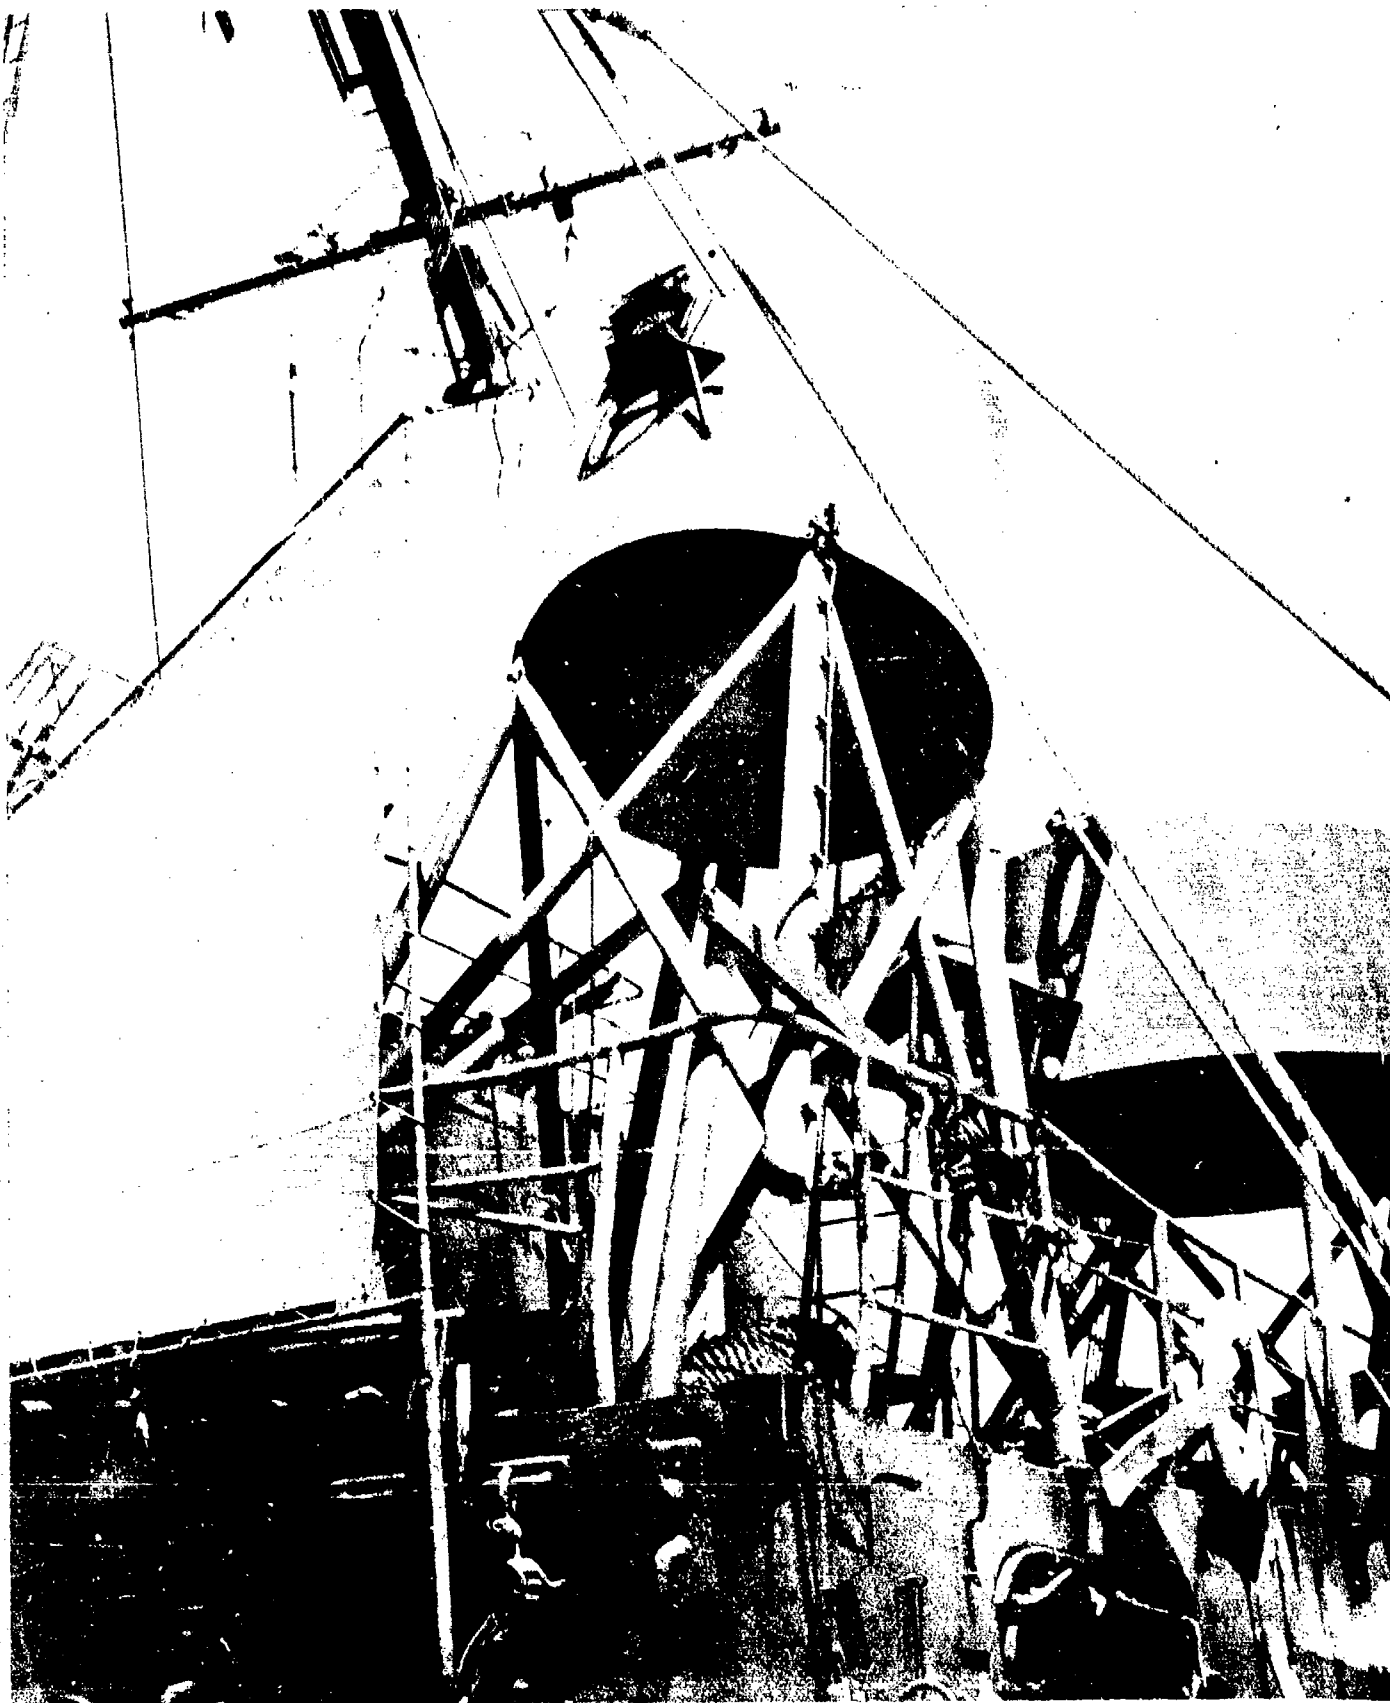
AA-CR-80-1906-10. Looking aft and to starboard from upper deck, port, showing damage to director foundations and doors missing to carpenter shop, dishing of deck house bulkheads.
